**Chioggia CBA02-Habitat** - Italy

Design, engineering and installation of an “underwater habitat at atmospheric pressure” (watertight space) for demolition / recovery works of a caisson roof of the Chioggia Flood Barrier.

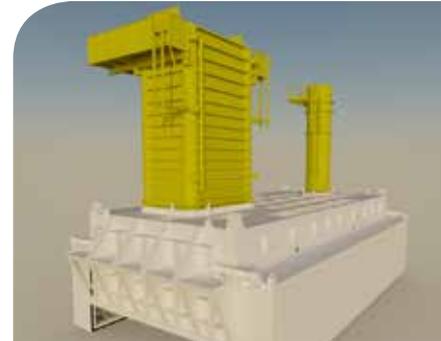
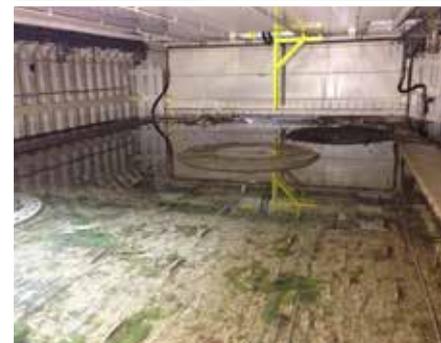
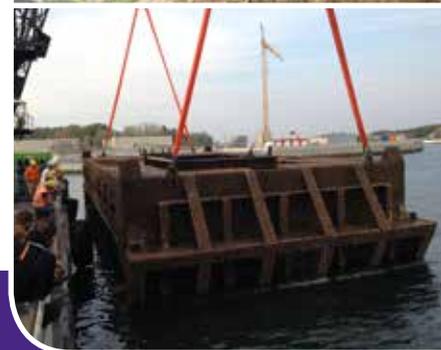
In six months' time a steel habitat was designed and constructed to be able to execute the required dry inspection, demolition and repair works. Design, preparations and installation of the habitat were within the scope of work of Strukton, where construction of the habitat and demolition/repair of the caisson roof were in the scope of the client. The habitat consisted of three parts (one middle section and two side boxes) and two access shafts. All parts were connected with specialized rubber seals. The weight of the total structure was about 400 ton and it was produced in a steel fabrication plant in Italy. After transport over water on a barge, all the parts were lifted and accurately positioned piece by piece with two floating cranes under water with diving assistance of OTN.

The main challenges of the project were the strict water tightness of the drained habitat in order to assure high quality inspection, demolition and repair results. Another restriction was the weight of the habitat parts in relation to the lifting capacity of the floating cranes. By limiting the structural impact on the caisson and providing a large dry working space, the concrete repairs could start and finish on time and within the quality requirements.

After the first successful installation in June 2015, the habitat was retrieved, and reinstalled on the second location in August. In total the habitat was in function for 18 weeks before final removal in October 2015, meeting all requirements of the client during the entire time.
